I-85 BRIDGE COLLAPSE AND RECONSTRUCTION

Bill DuVall, P.E.
Georgia DOT

Adam Grist, Vice President - Structures
C.W. Matthews Contracting Co., Inc.

**Atlanta Business Roundtable
November 16, 2017**

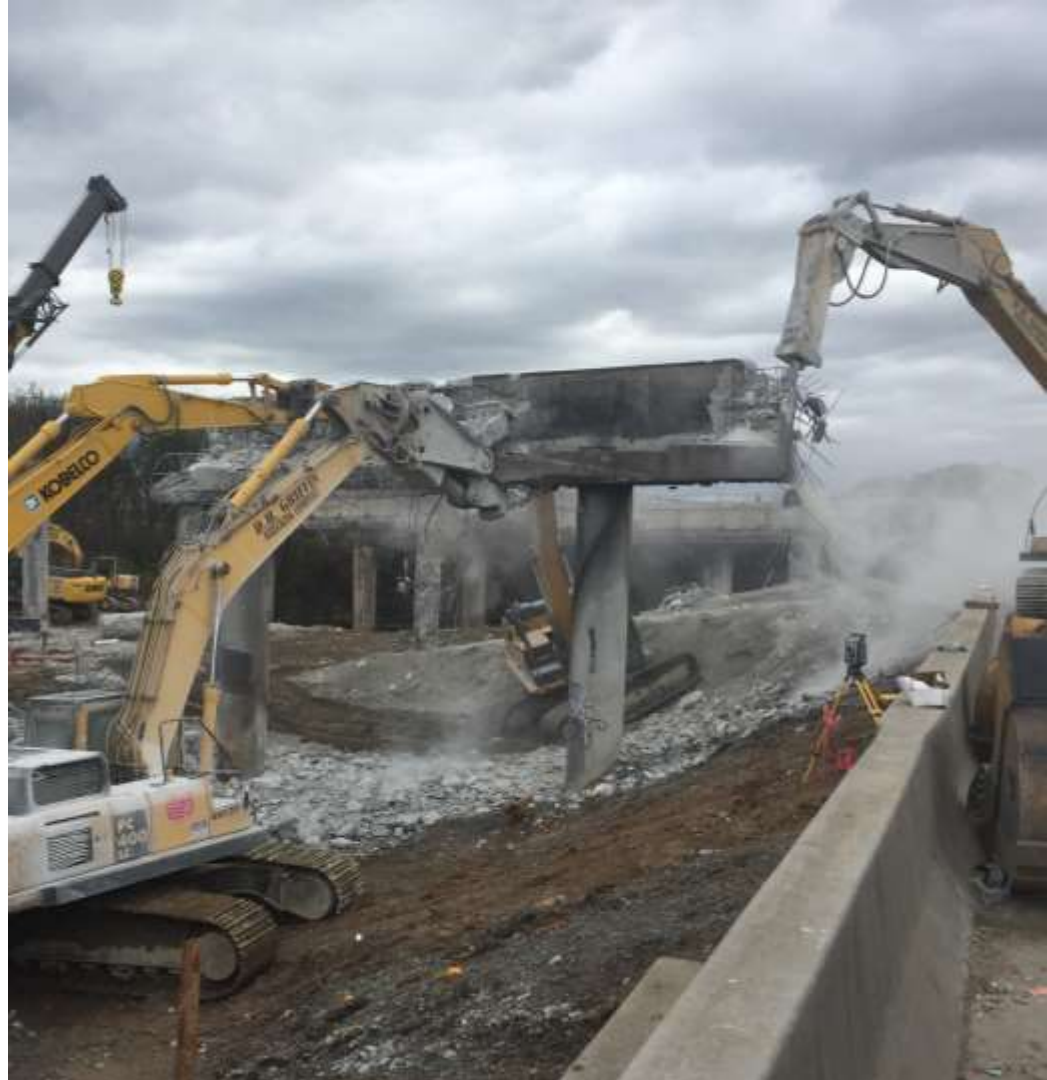
Preserving Substructure

- CWM and DHG
- Cap demo without damaging columns

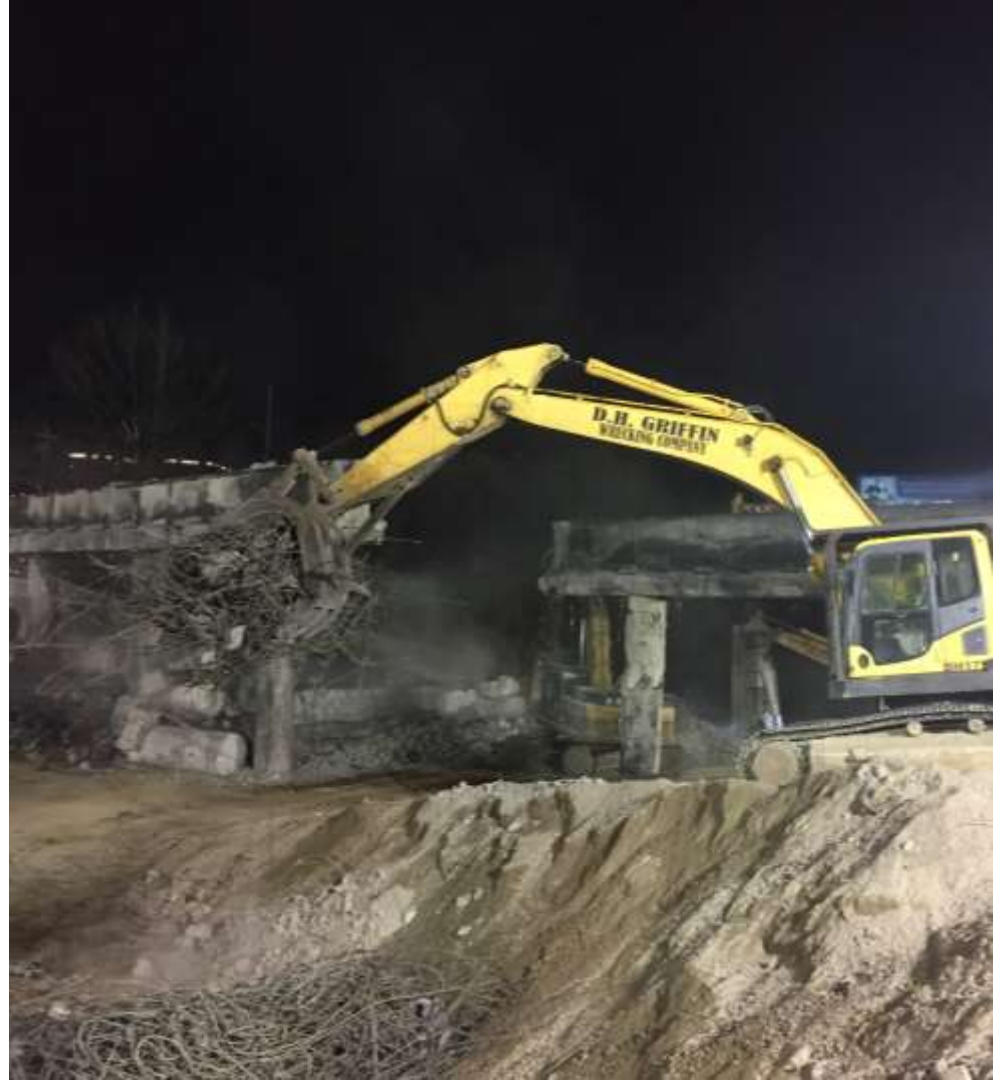
Reduce, Re-use

- Demolition complete, April 6 - Day 7
- Rebar and concrete transported to recycling facilities

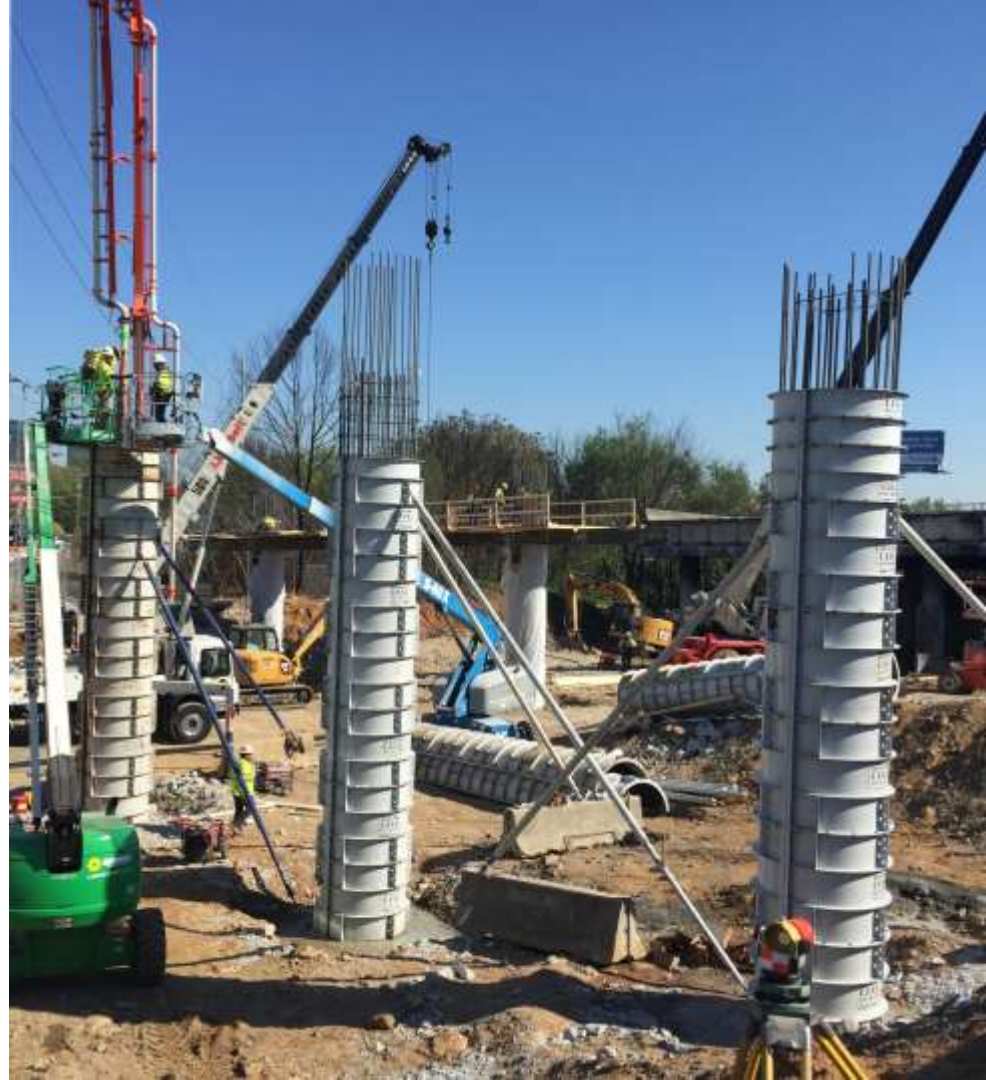
Reduce, Re-use

- Existing bridge foundations re-used
- New columns 1-ft wider than originals
- 13 Columns completed April 11, Day 12

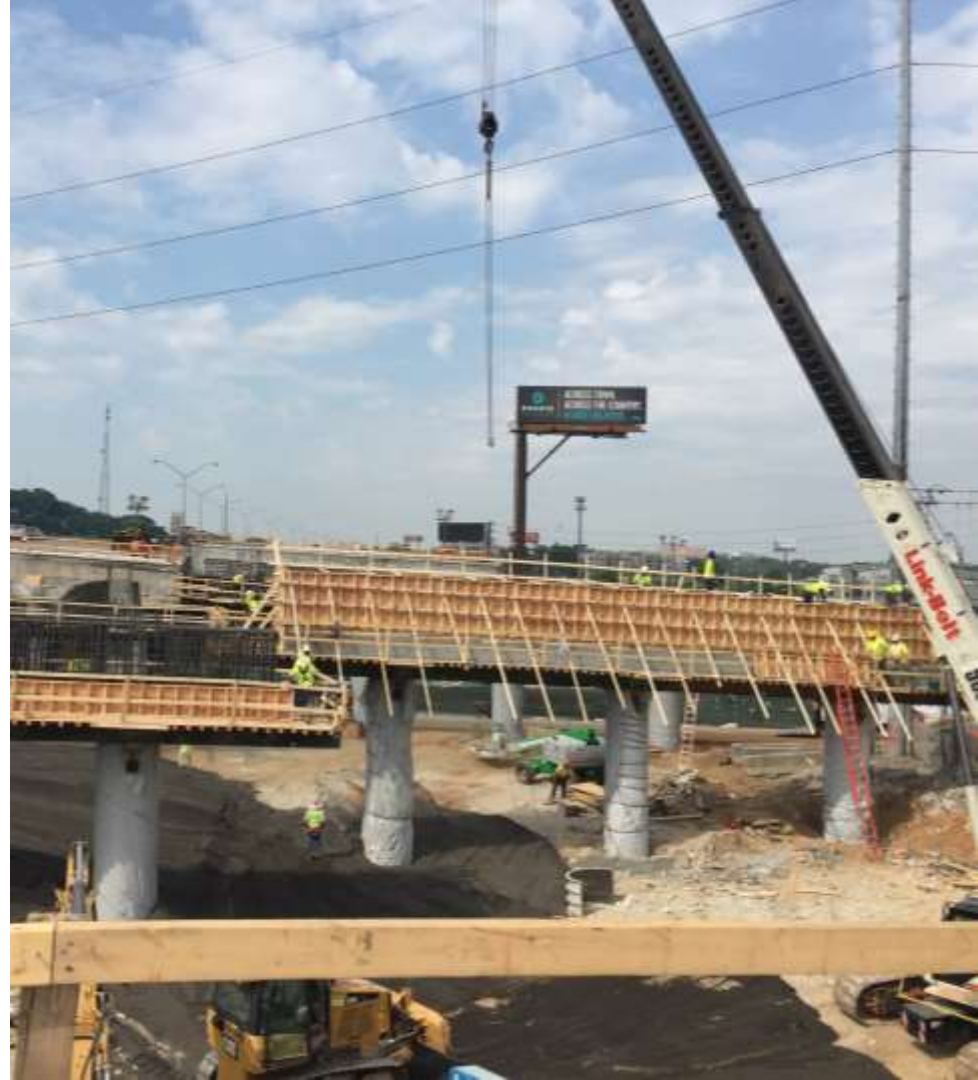
4 New Caps

- Inverted “Tee” Cap
- Field Issues Addressed
- 4 Caps completed
April 17, Day 18

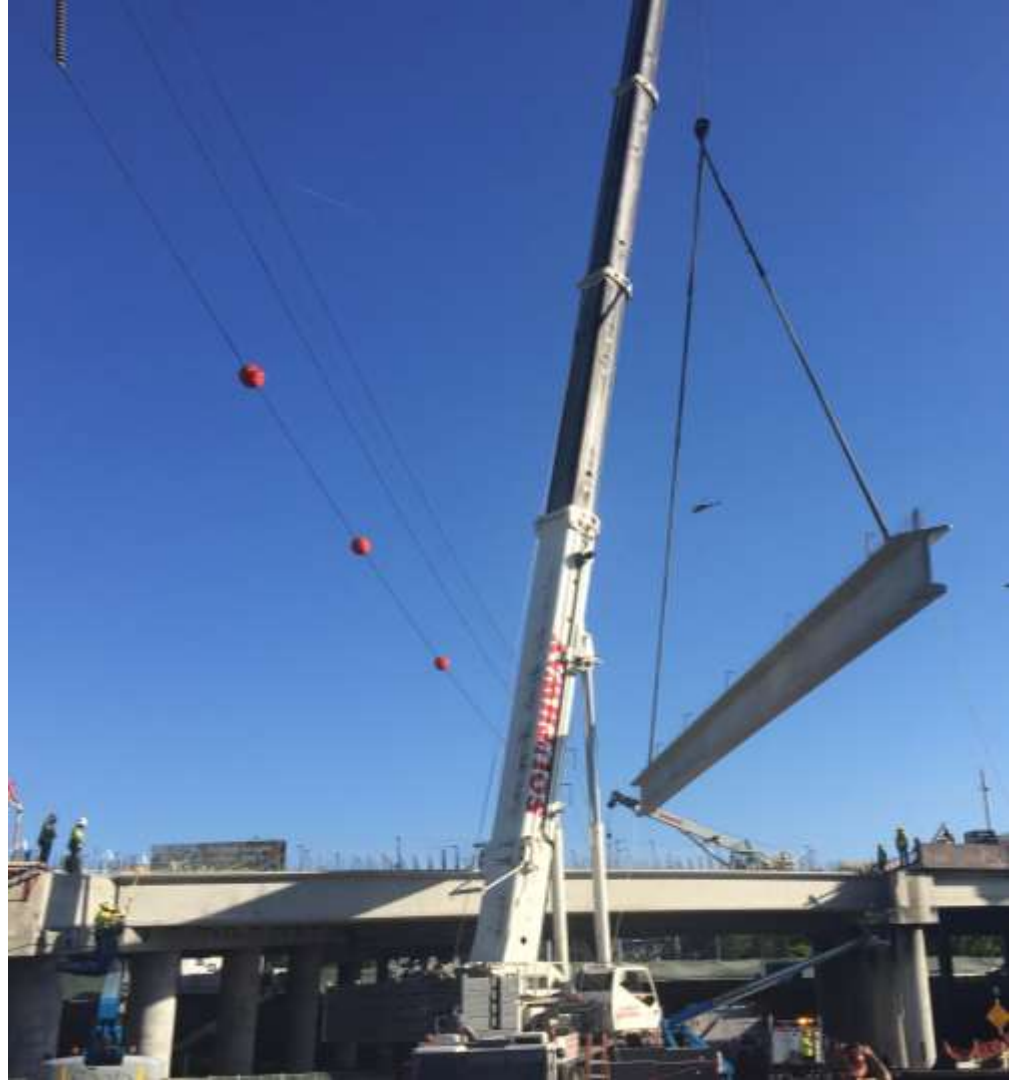
Shipping and Setting Beams

- Specialized trailers haul beams from Standard Concrete (ATL)
- Approach Plan
- 61 Beams Set
April 25, Day 26
